System-Wide Ecological Conditions
Status Update
July 10, 2008

***Susan Gray, Ph.D., Deputy Director,
Watershed Management Department***

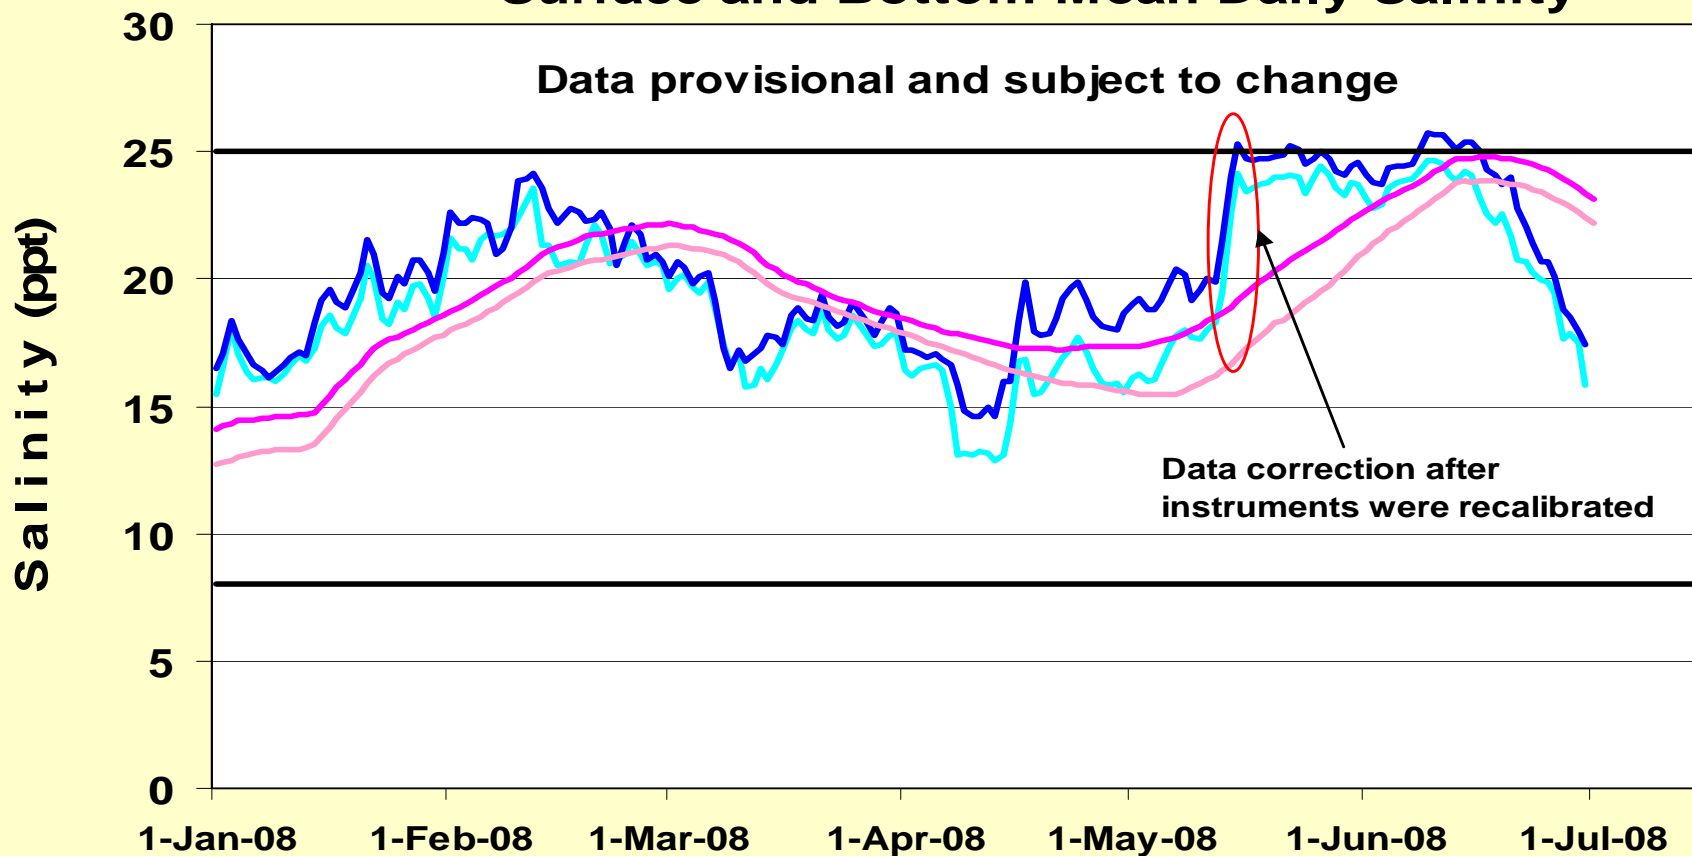
St. Lucie Estuary Salinity: US 1 Bridge

Salinity Envelope Surface and Bottom Mean Daily Salinity

— US1 surface daily mean

— 30 day prior US1 surface daily mean

— US1 bottom daily mean

— 30 day prior US1 bottom daily mean

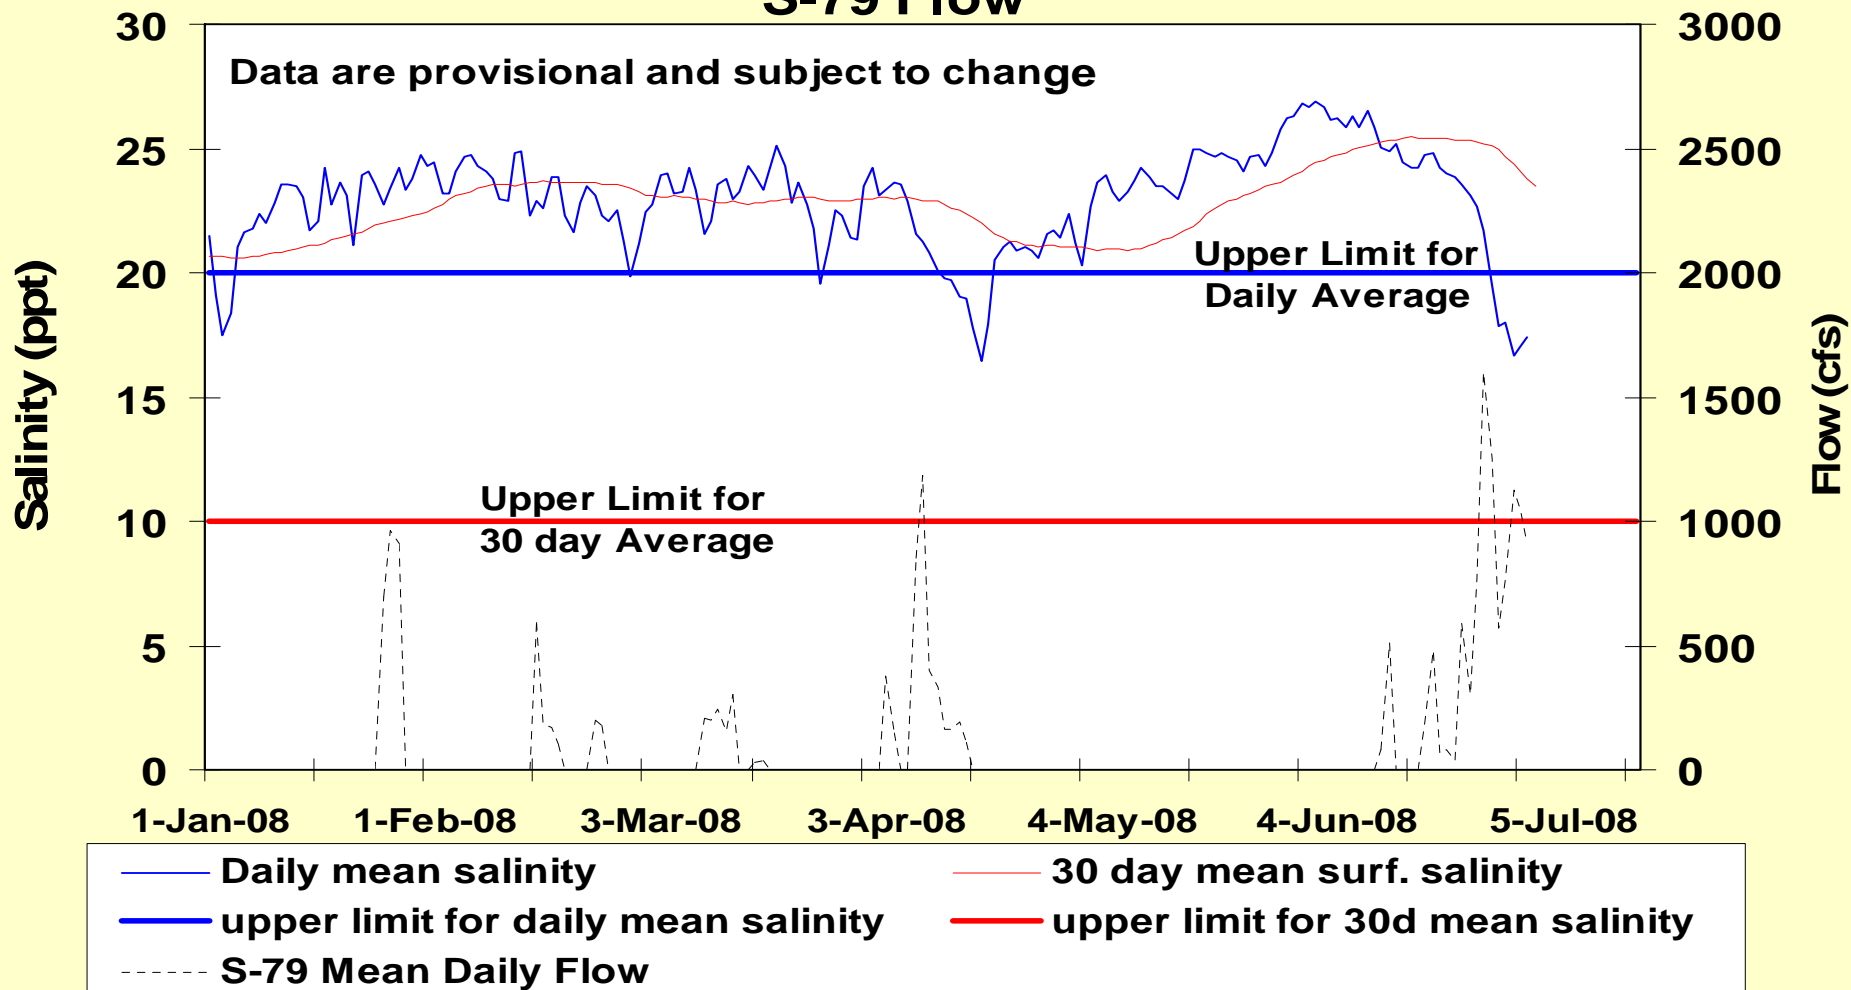
Caloosahatchee Salinity: Ft. Myers

Surface Salinity at Ft. Myers: MFL S-79 Flow

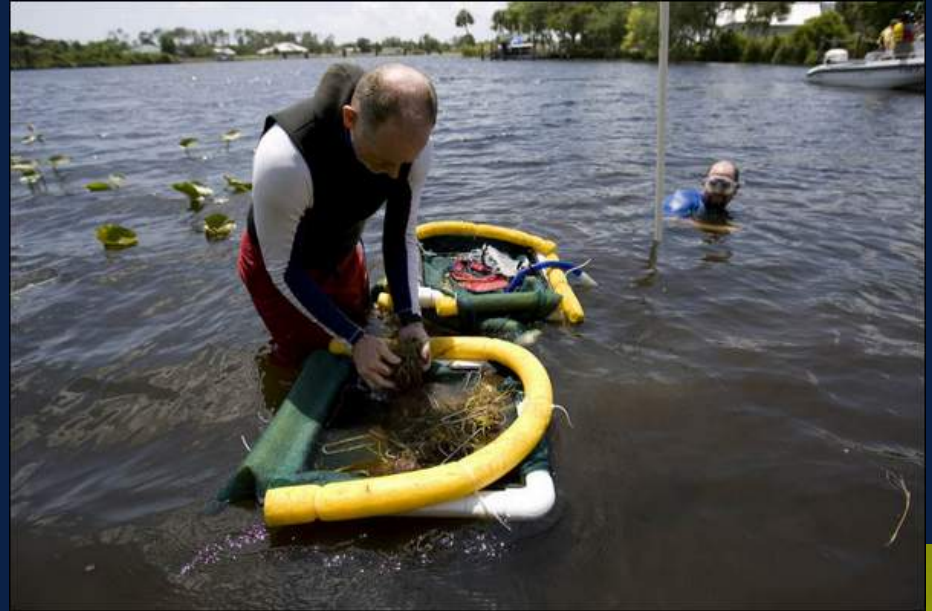
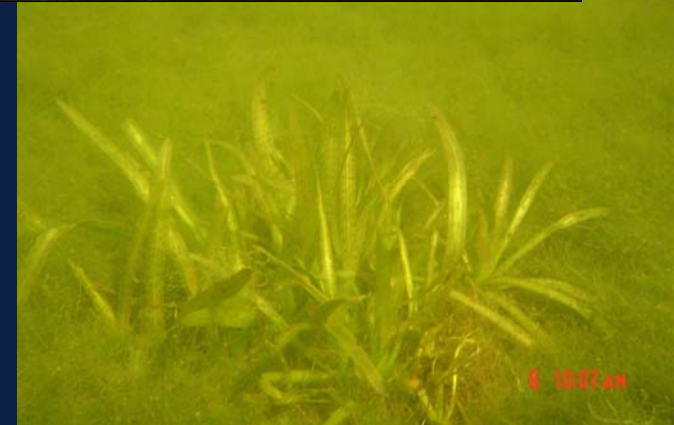
Tape Grass Planting and Algae Blooms in the Caloosahatchee River (C-43)

- **Plants Survived Low Light Conditions During the Blue Green Algae Bloom**
- **Plant Blades are 15-90 cm in Length**
- **Within Cages Aerial Coverage is 60 – 100%**

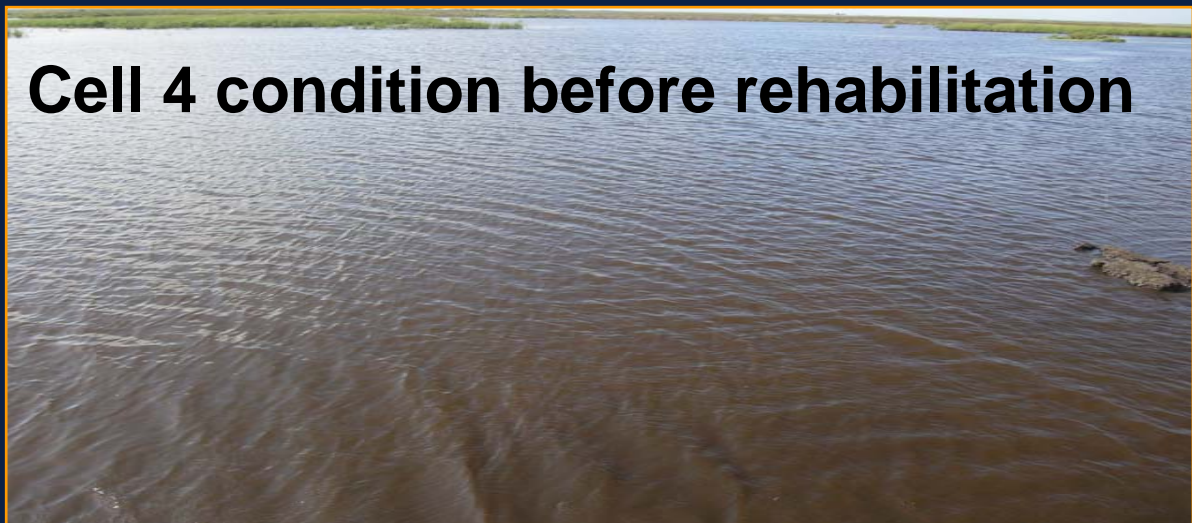
Cell 4 condition before rehabilitation

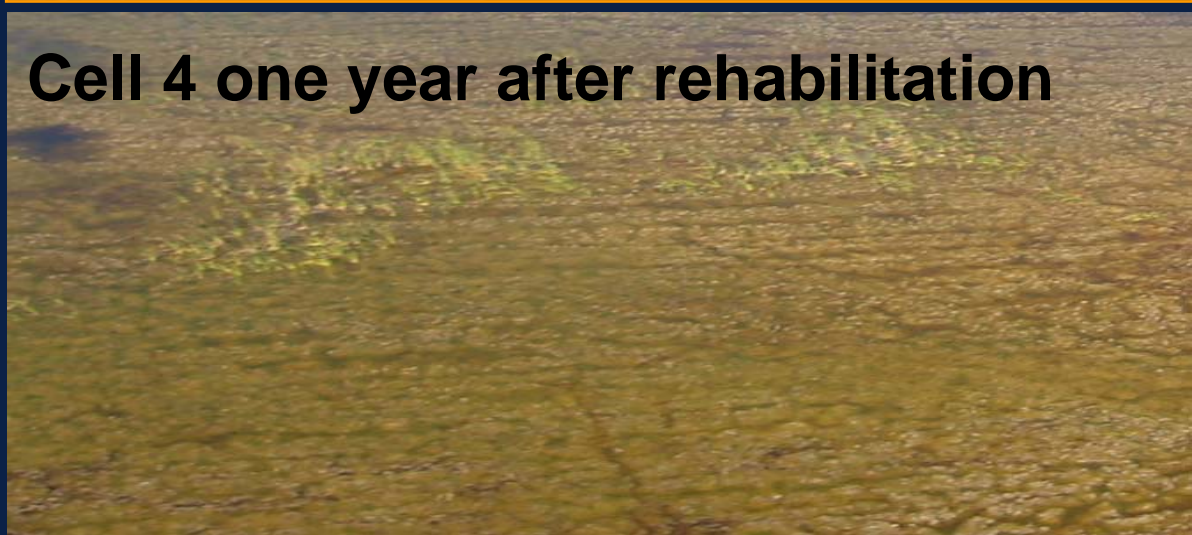
Cell 4 one year after rehabilitation

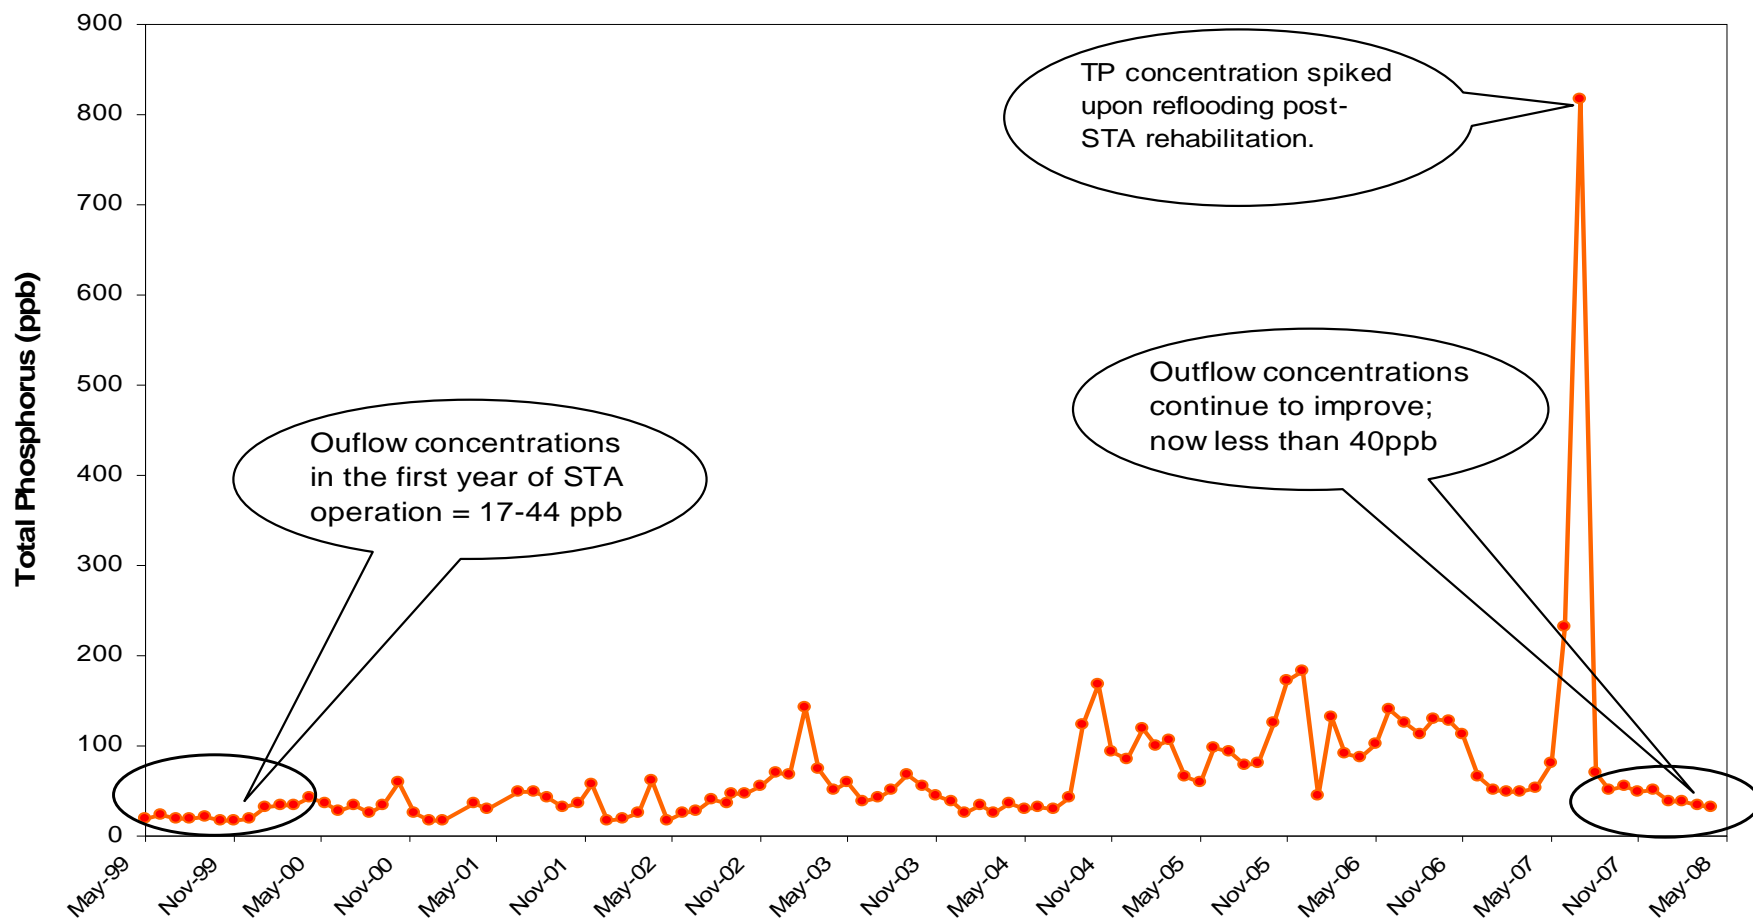
STA-1 West Performance After 2007 Rehabilitation

STA-1W Outflow (G-251 and G310) Flow-weighted Mean Total Phosphorus Concentration
(Most recent 3 months may contain preliminary data.)

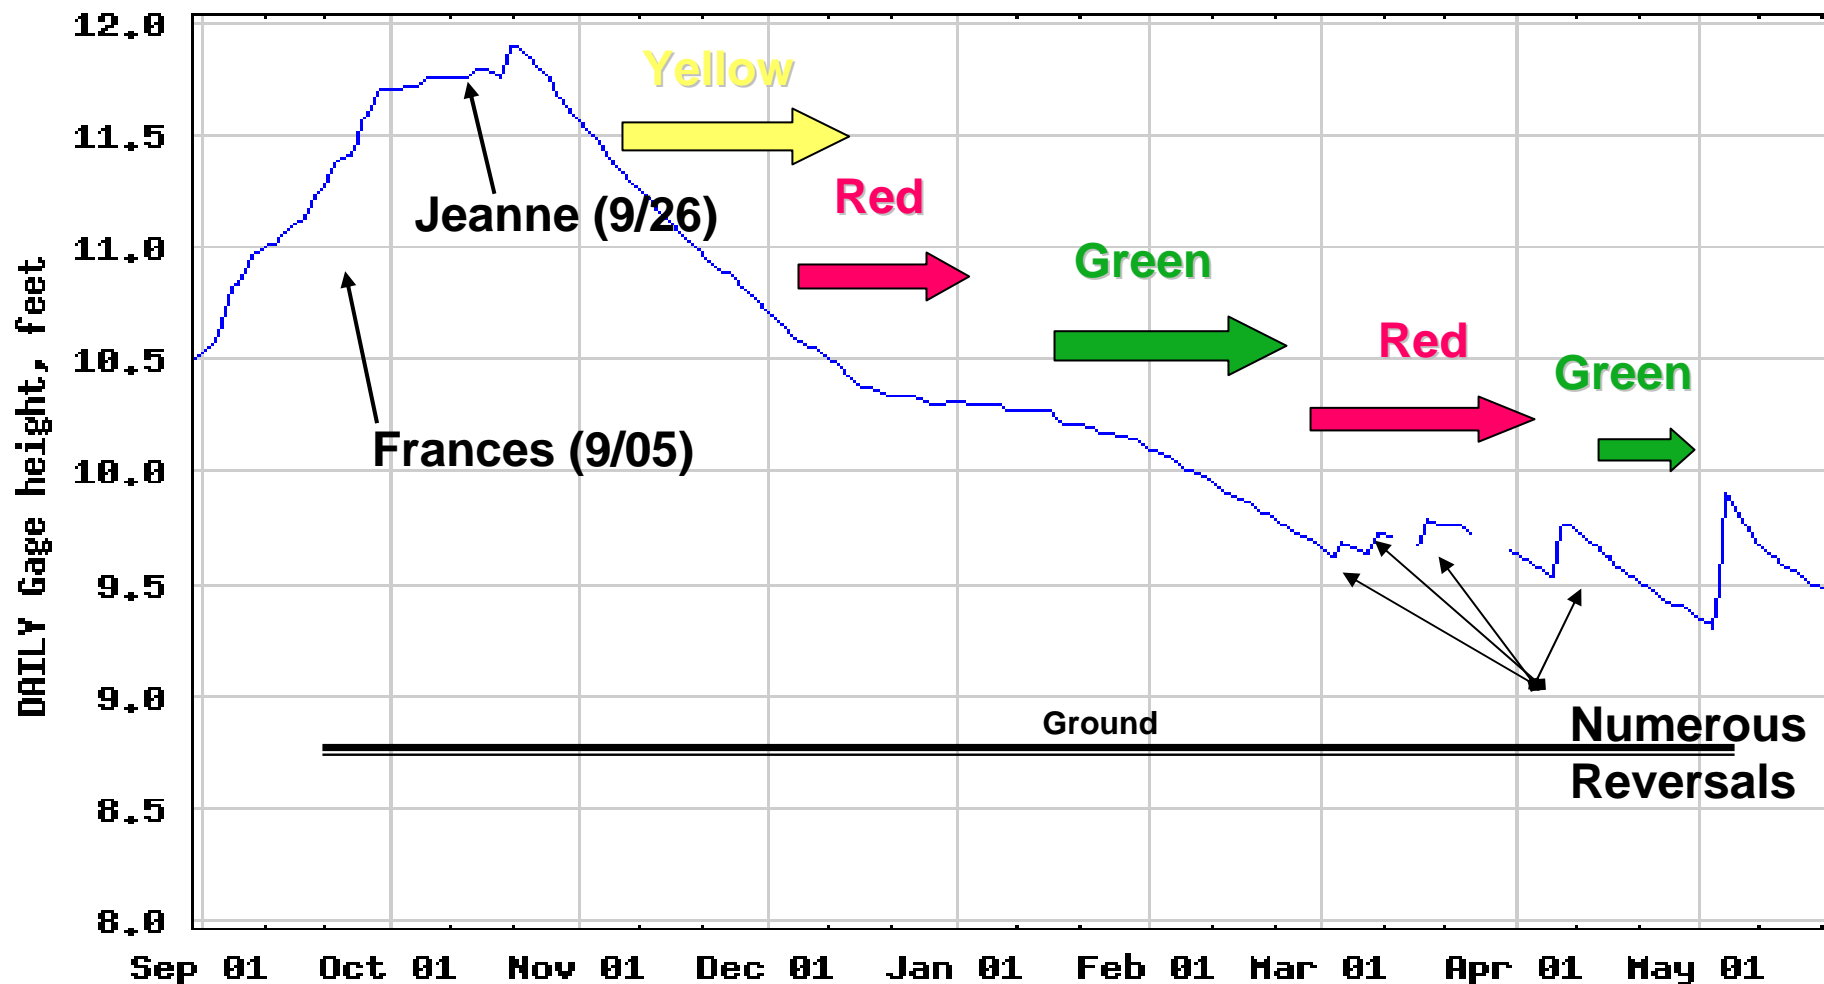
Hydrologic Recession Trends (09/04-05/06) in Central-WCA-3A

- Nesting success is tied to both the water depth and rate of decline in water level
- Slow declines in water levels concentrate food for the birds
- Too fast a decline in water level can lead to fish kills
- “Reversals” or upward trends during nesting make foraging more difficult

SGS 255828080401301 SITE 64 IN CONSERVATION AREA 3A NR COOPERTOWN F

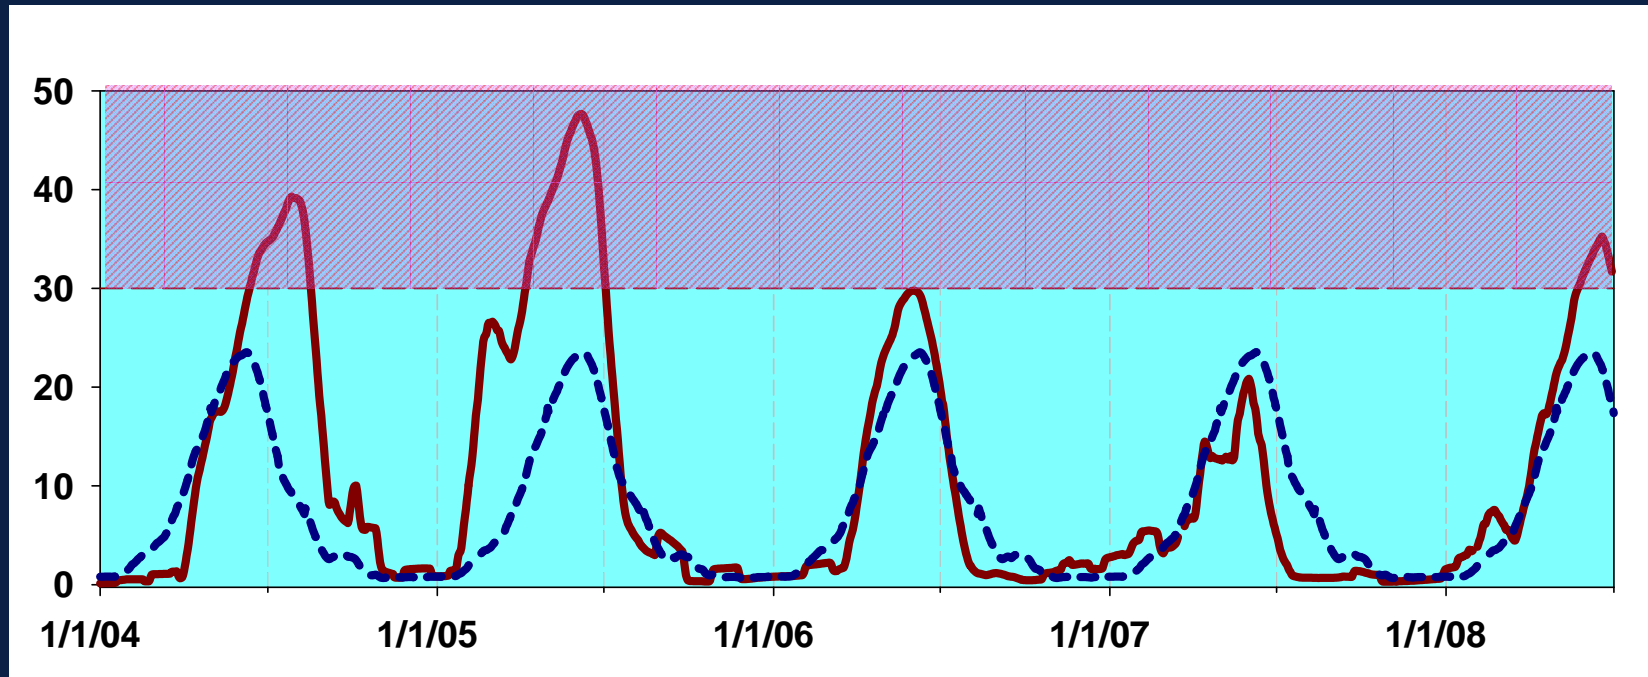
Tracking salinity in mangrove ponds for Florida Bay MFL criteria

TR 30 d running
average salinity (ppt)

Daily value at Taylor River
– red line

Long-term mean
(WY97 – 07) – dashed line
